Tip replacement instruction

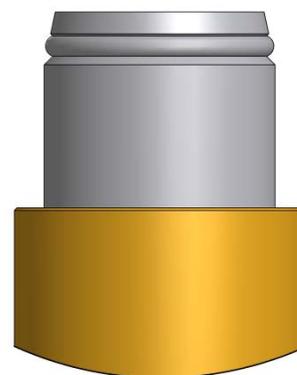
Wear limit indicator

It is extremely important that the tip is not worn passed the wear limit indicator, see the picture.

A wear beyond the limit can result in a plate crash and also affect the security of the refiner in other ways. The tip should be replaced at every plate change to secure the sensor tip life time and to refresh the sealing's into the AGS tube and house.

Bad sealing may result in leakage of process fluids into the AGS house or a stuck tip which will prevent production calibration.
